Resurrection Creek Stream and Riparian Restoration Project

Stream Channel and Vegetation Monitoring Report, 2005 through 2008

USDA Forest Service Chugach National Forest

January 2009

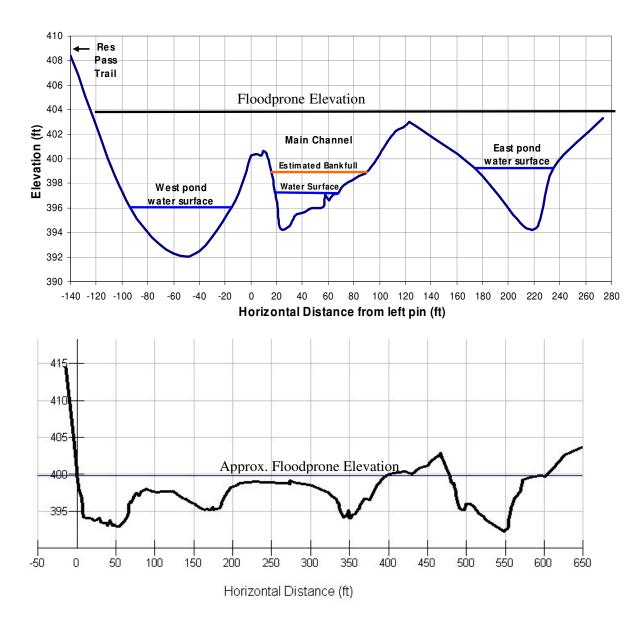
Field measurements verify these mapbased generalizations. Entrenchment ratios measured at 3 sites in the field ranged from 3.4 to 5.3 (**table 2.1**, **figure 2.2**).

**Figure 2.2**: Valley cross sections at riffle cross section 8+90 (top) and upper valley cross section (bottom), showing floodprone elevations and widths (10X vertical exaggeration).

Entrenchment ratios in the restored reach average about 4. This is less than the stated objective (entrenchment ratios greater than 6). However, the floodprone width was limited in places by narrower valley widths, as little as 300 feet, which would only allow for entrenchment ratios of up to about 4. In other areas, constructing floodplains greater than 450 feet was impractical or would have been cost prohibitive. Entrenchment ratios of about 4 will likely be sufficient to allow for floodplain function for this channel.

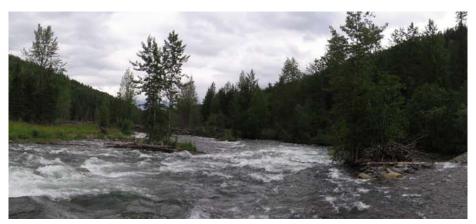
The constructed logiams have held up well in the 2 to 3 years since their construction. They were designed to maintain themselves through continued recruitment of new wood from upstream. Woody debris has been observed floating from upstream of the restored reach, often the result of beetle-kill spruce that has fallen into the channel during high flows. In some cases, these logs have accumulated on existing logiams or at the heads of islands within the project reach (**figure 2.7**).

Beavers are another important factor affecting wood accumulation in the project reach. Beavers have felled numerous trees along the Resurrection Pass Trail near where it is adjacent to Meander 3. Many of these trees have fallen into the pool at Meander 3 and have lodged into the log jam, providing extra habitat and adding to the integrity of the logjam (**figure 2.7**). The only observed beaver dam in the project area is located in the upper project area, enlarging a small pond adjacent to the lower end of Channel 1. No side channels have been blocked by beaver dams up to this point.

**Figure 2.7**: Accumulation of new trees felled by beavers into the Meander 3 logjam, and accumulation of trees at the head of and island at the Meander 4 riffle.

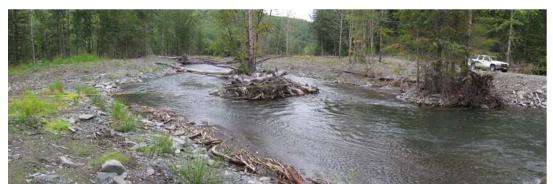
Excellent spawning gravel also exists on Palmer Creek (**figure 2.9**) and in portions of Channel 1 (**figure 2.10**). Surveys of cross section 3+61 in Palmer Creek shows accumulation of abundant gravel in the 16mm to 32mm size class (averaging 21mm) in long sections of low gradient channel where spawning habitat exists. On Channel 1, spawning gravel observed in pool tails (XS 5+55) and low gradient sections (XS 1+05) are predominantly in the 22mm to 90mm size range, averaging about 34 to 49mm.

Figure 2.9: Spawning area on a low gradient section of Palmer Creek (Aug 27, 2008).

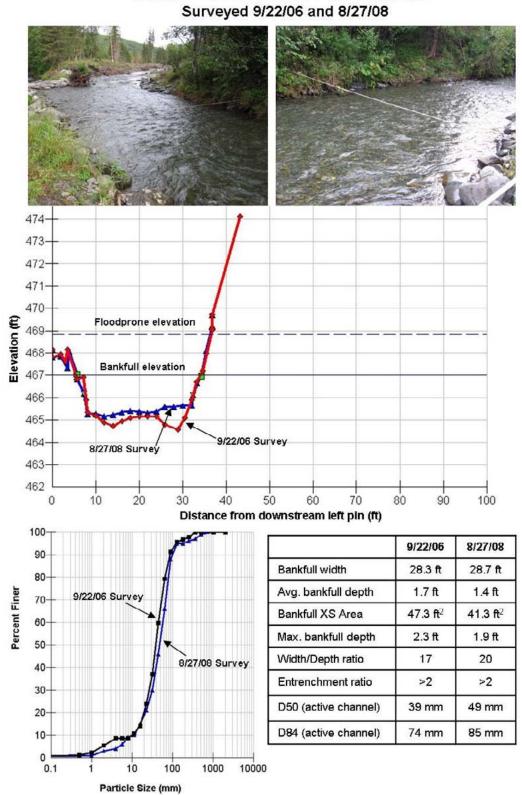
Channel 1 Cross Section 1+05 - Riffle/Run

Figure 3.3: Changes in Channel 1 cross section 1+05 (riffle/run) from 2006 to 2008.

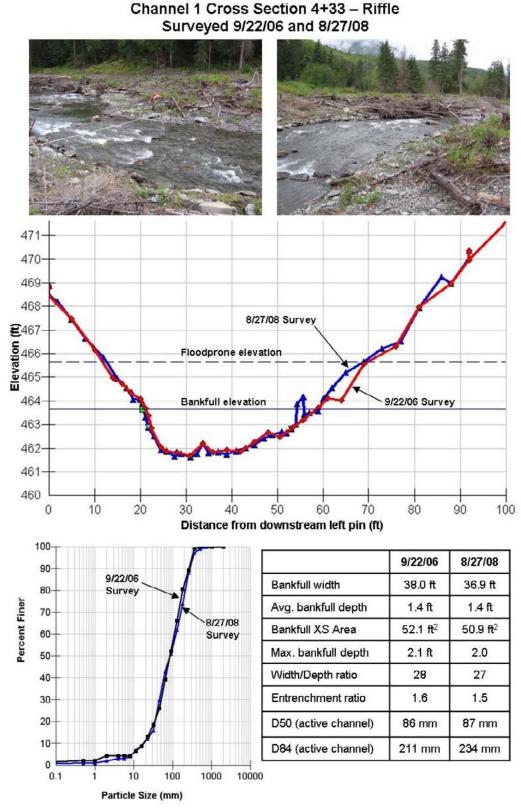
Figure 3.4: Changes in Channel 1 cross section 4+33 (riffle) from 2006 to 2008.

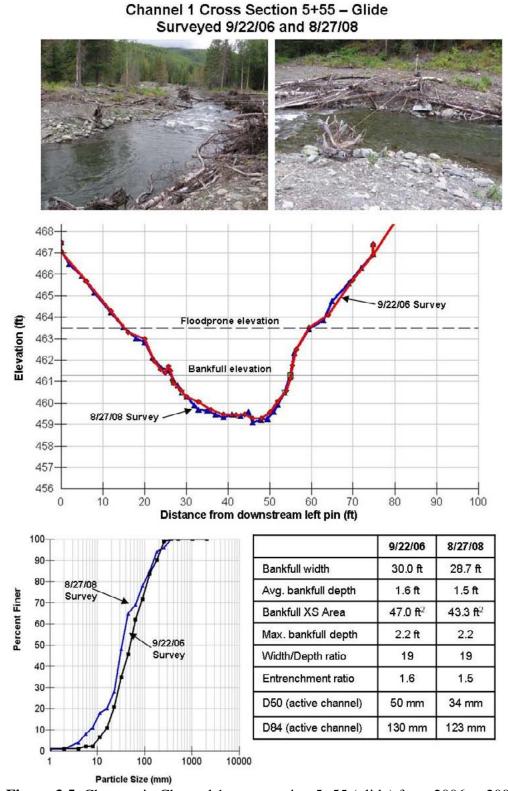
Figure 3.5: Changes in Channel 1 cross section 5+55 (glide) from 2006 to 2008.

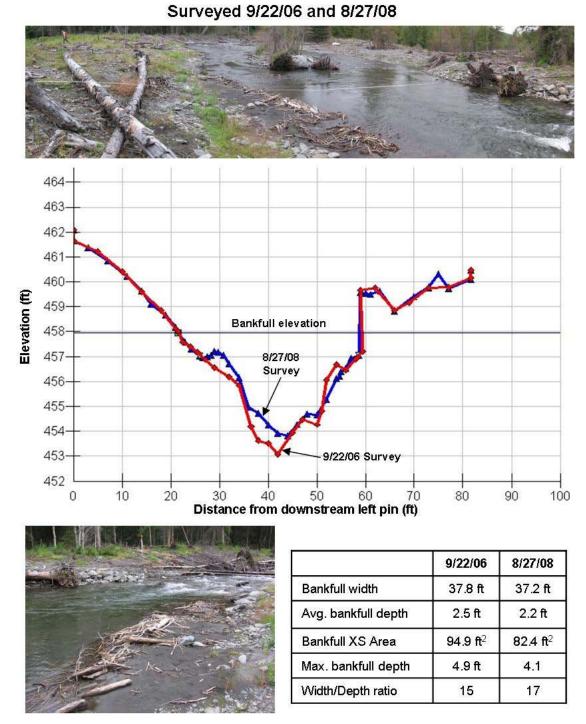
Channel 1 Cross Section 7+07 - Pool

Figure 3.6: Changes in Channel 1 cross section 7+07 (pool) from 2006 to 2008.

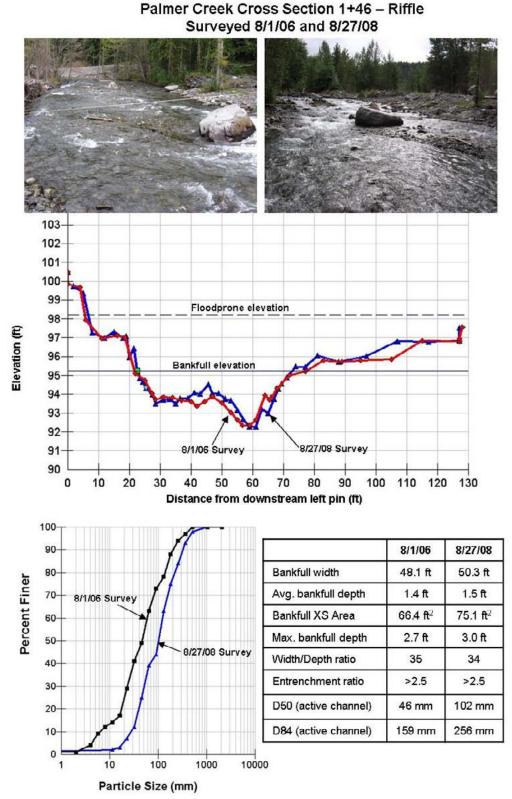
Figure 3.8: Changes in Palmer Creek cross section 1+46 (riffle) from 2006 to 2008.

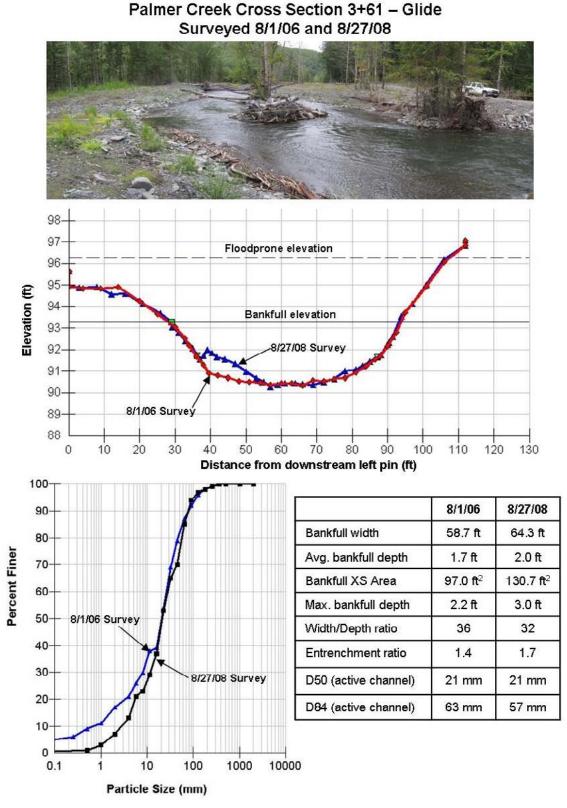
Figure 3.9: Changes in Palmer Creek cross section 3+61 (glide) from 2006 to 2008.

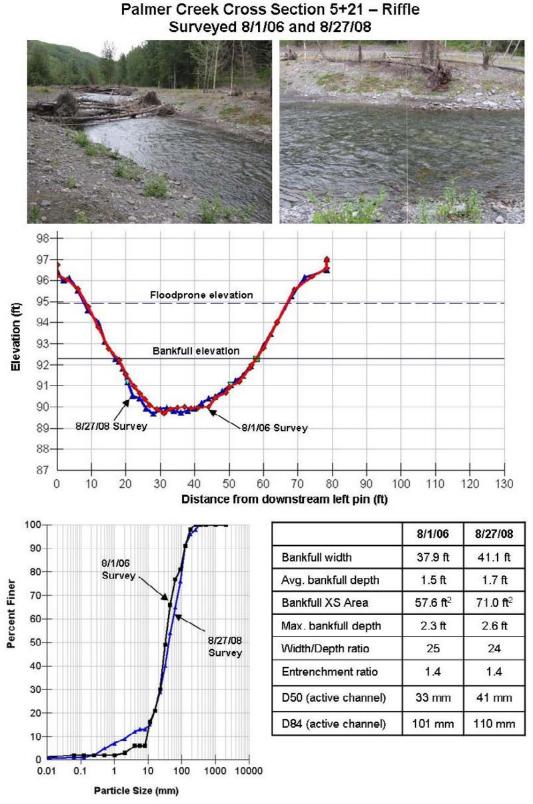
Figure 3.10: Changes in Palmer Creek cross section 5+21 (riffle) from 2006 to 2008.

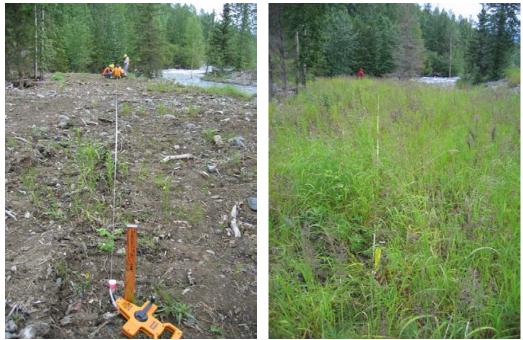
**Figure 3.15**: Conversion from bare soil dominance (64% cover) on Transect 1 in 2006 (left) to dominance by bluejoint reedgrass (*Calamagrostis canadensis*; 31%), common horsetail (*Equisetum arvense*; 11%), and tall fireweed (*Epilobium angustifolium*; 10%) in 2008 (right).

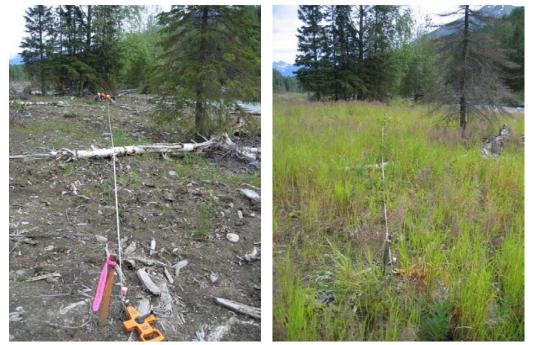
**Figure 3.16:** Conversion from bare soil dominance (67% cover) on Transect 2 in 2006 (left) to dominance by bluejoint reedgrass (*Calamagrostis canadensis*; 43%) and common horsetail (*Equisetum arvense*; 20%) in 2008 (right).

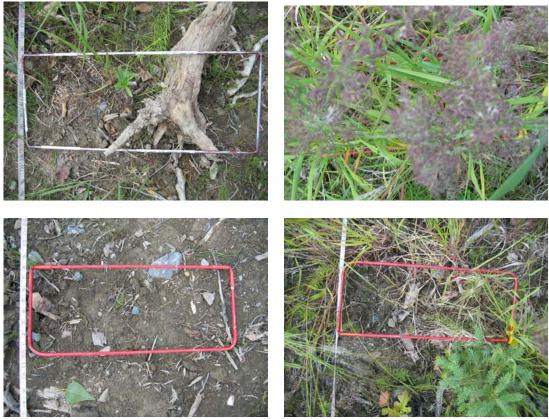
**Figure 3.17.** Two (of the 20) quadrat frames (20 by 50 cm) along Transect 2. In both cases, vegetation cover is sparse in 2006 (left) but well represented in 2008 (right). Dominant species in 2008 in frame 1 (top) are bluejoint reedgrass (*Calamagrostis canadensis*; 85% cover) and common horsetail (*Equisetum arvense*; 60%) and in frame 19 (bottom) are bluejoint reedgrass (15%), common horsetail (15%), and fowl bluegrass (*Poa palustris*; 15%).

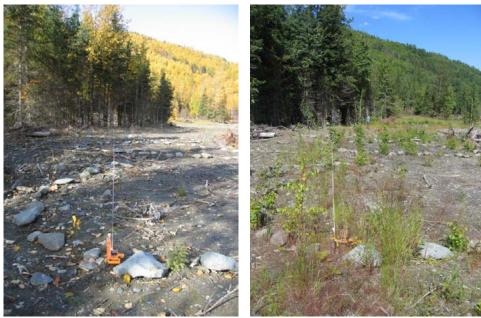
**Figure 3.20:** Bare soil cover declined from 63% in 2006 to 40% in 2008 on Transect 5 while the dominant plant species, tickle grass (*Agrostis scabra*), increased from a trace in 2006 to 8% cover in 2008. The young trees shown include paper birch (*Betula papyrifera*) and white spruce (*Picea glauca*) planted by the Youth Restoration Corps.

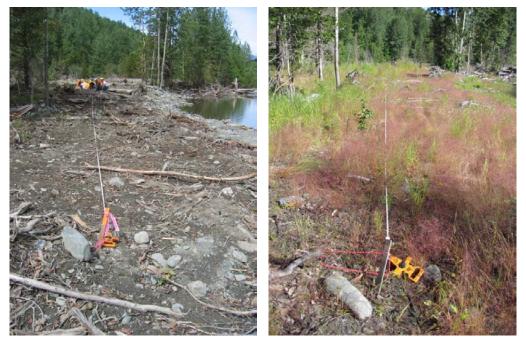
**Figure 3.21:** Conversion from bare soil dominance (55% cover) on Transect 6 in 2006 to dominance by tickle grass (*Agrostis scabra*; 50%), common horsetail (*Equisetum arvense*; 10%), and bluejoint reedgrass (*Calamagrostis canadensis*; 8%) in 2008.

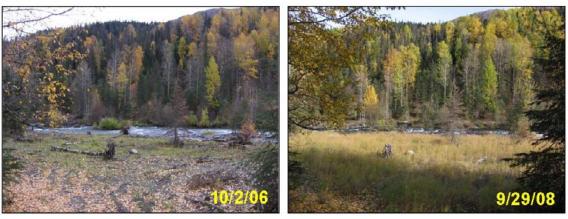
**Figure 4.12**: Resurrection Creek Photo Point 15b (panorama). This shows the western floodplain between Meander 2 and Meander 3. Abundant vegetation has grown as a result of the natural soils placed on the floodplain. The "meander scar" side channel in the center of the photo carries perennial flow from groundwater.

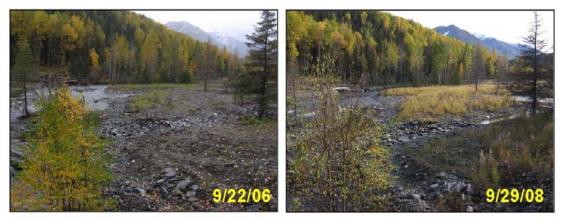
**Figure 4.15**: Resurrection Creek Photo Point 17b. This shows the Meander 4 riffle. Few channel changes have occurred.

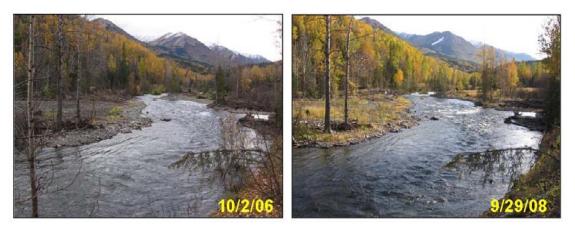
**Figure 4.17**: Resurrection Creek Photo Point 20. This shows Meander 2. Few major channel changes are evident in this photo.

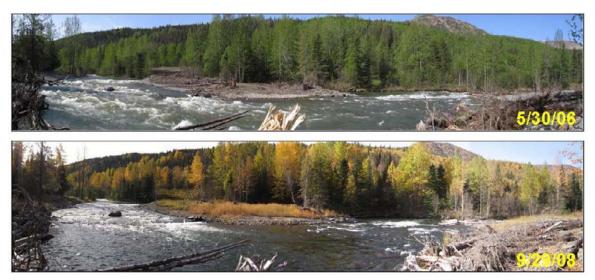
**Figure 4.19**: Resurrection Creek Photo Point 22, showing the lower Meander 3 riffle and logiam. Few channel changes have occurred in this riffle.

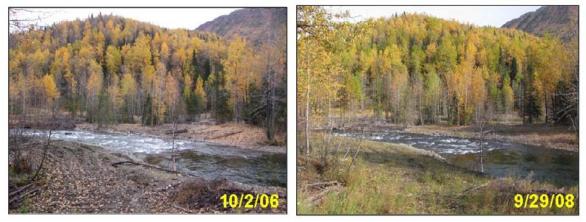
**Figure 4.21**: Resurrection Creek Photo Point 25 (panorama), showing the lower riffle of Meander 5. Although this riffle is one of the steepest in the project reach, no headcutting is evident in the 2 years since project completion. However, the riffle has adjusted to a more uniform slope.

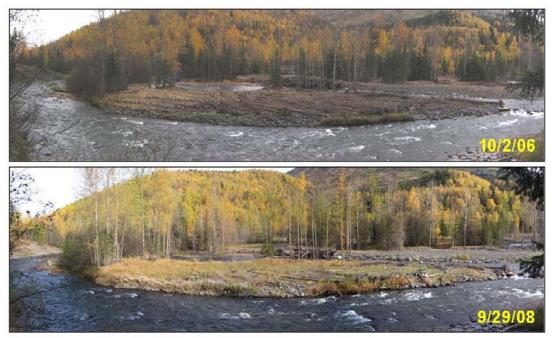
**Figure 4.23**: Resurrection Creek Photo Point 27 (panorama), showing the lower riffle of Meander 5. Although this riffle is one of the steepest in the project reach, no headcutting is evident in the 2 years since project completion.

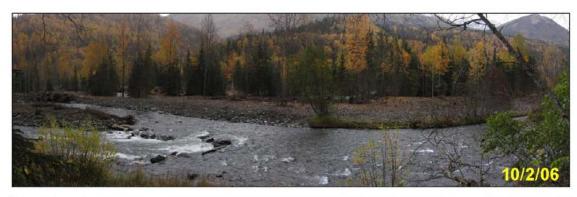
**Figure 4.24**: Resurrection Creek Photo Point 29 (panorama), showing the Upper Reach Split Channel and island. Vegetation growth has occurred where soil was spread on the island.

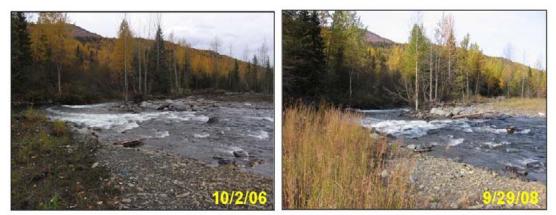
**Figure 4.33**: Resurrection Creek Photo Point 45, showing the lower riffle and logjam of Meander 5. Few major channel changes have occurred at this location.
